# **INDOOR AIR QUALITY ASSESSMENT**

**Thomas Passios Elementary School  
1025 Massachusetts Avenue  
Lunenburg, Massachusetts**

Prepared by:  
Massachusetts Department of Public Health  
Bureau of Environmental Health Assessment  
July, 2000

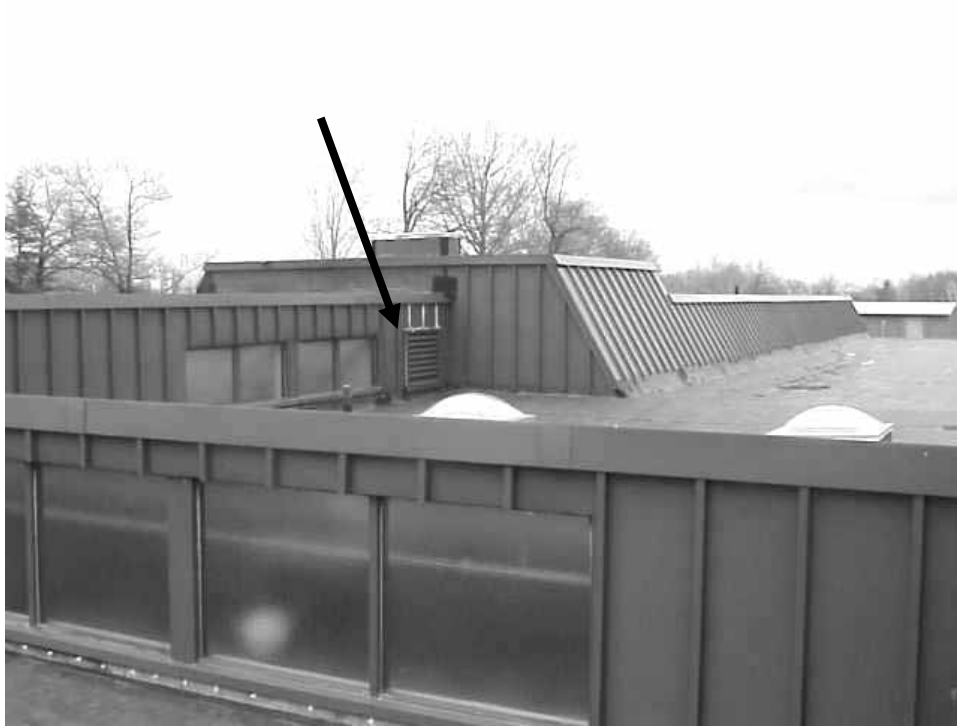
**Picture 1**

Ventilation in classrooms is provided by air handling units (AHUs) in each wing of the building. Fresh air intakes for AHUs are located on the roof (see Picture 1). These AHUs are connected by ductwork to fresh air diffusers located above the classroom hallway door. No airflow was detected from these fresh air diffusers, which indicates that the AHU system was either deactivated or blocked. A control switch located in a maintenance storeroom was activated, which in turn activated the AHUs. In order to provide fresh air to classrooms, the ventilation system must be activated while the building is occupied.

**Fresh Air Intake on the Roof**

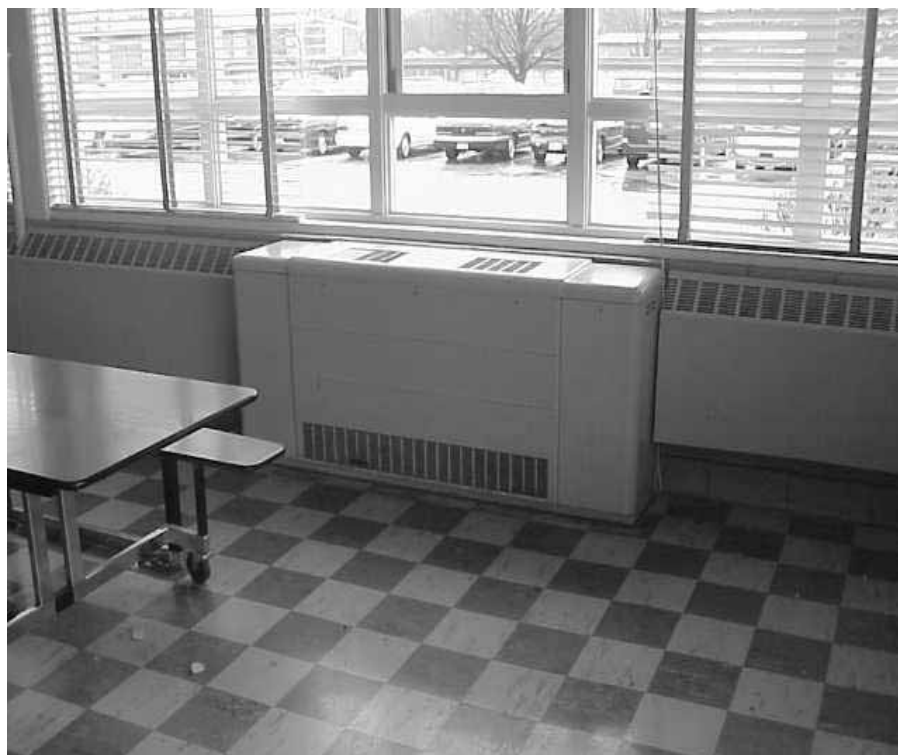
**Picture 2**

The cafeteria has unit ventilators (univents) that provide fresh air (see Picture 2). A univent draws fresh air from a vent on the exterior of the building and air from the room (called return air) through a vent in the base of its case (see [Figure 1](#)). Fresh air and return air are mixed, filtered, heated and expelled into the classroom through a fresh air diffuser located in the top portion of the case. A rolling refrigerator (see Picture 3) blocked the return vent of one univent. Fresh air supply and return vents must remain free of obstructions in order to function as designed.

**Cafeteria Univent**

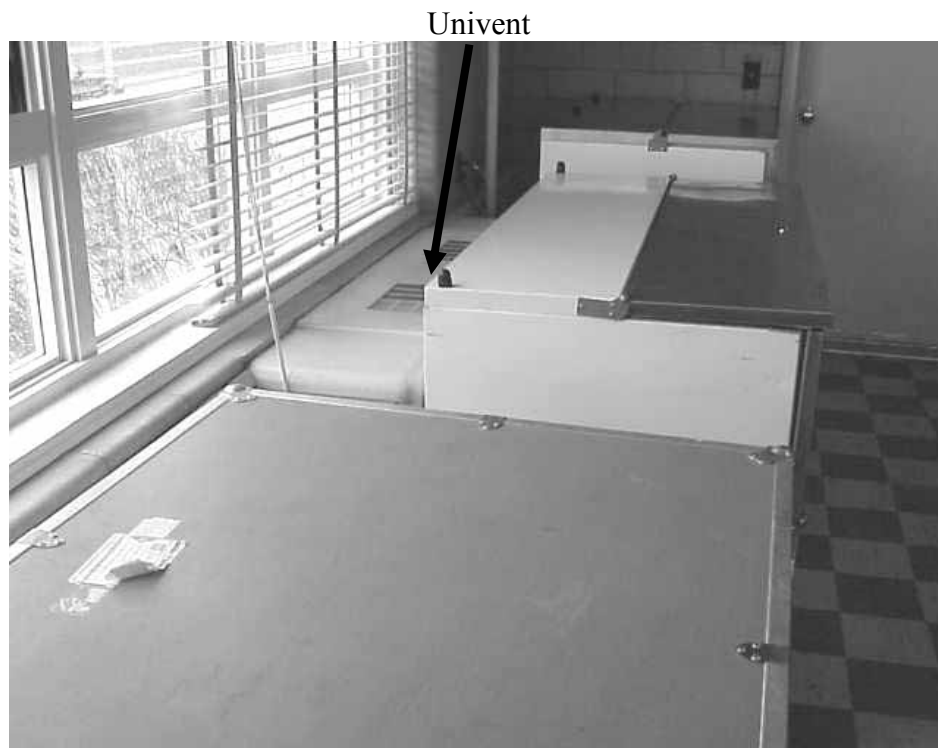
**Picture 3**

**Cafeteria Univent Blocked by Rolling Refrigerator**

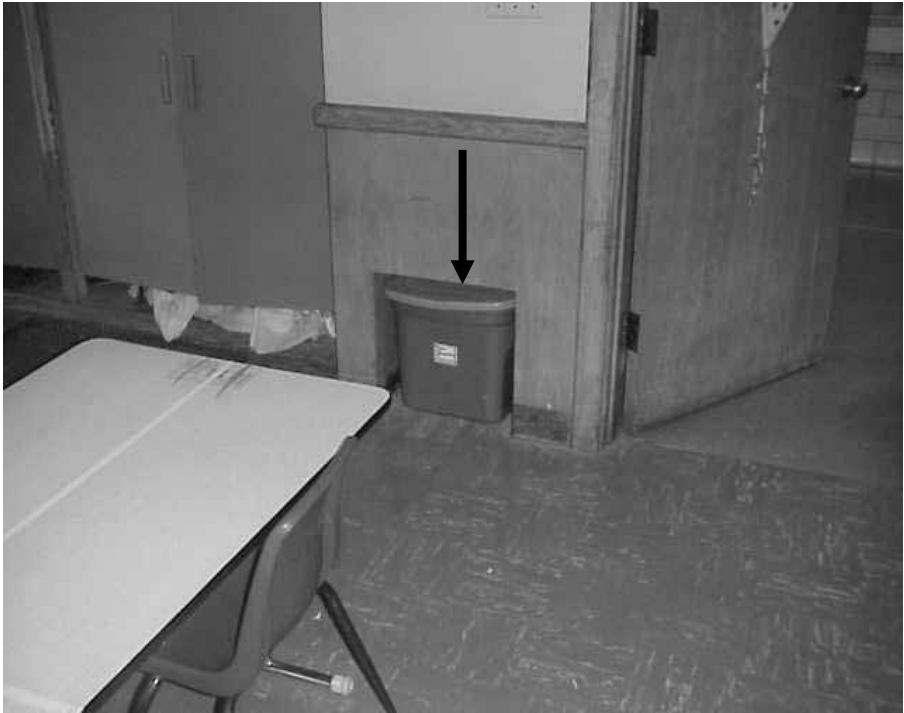
**Picture 4**

The school has two different types of exhaust ventilation systems. In classrooms, exhaust ventilation is provided by ungrated holes connected to a ducted exhaust system (see Picture 4), which in turn are connected to the AHUs. Airflow is controlled by a flue, which is opened by a draw chain-pulley system (see Picture 5). The flue is set at a desired angle by setting the draw chain in a locking mechanism. These flues were found closed in a number of rooms surveyed. In addition, the vents were observed to be used for storage (see Picture 4 and 6). These vents need to be free of obstructions in order to function as designed.

**Classroom Exhaust Vent**

4. Remove stored materials from exhaust vents in classrooms. Ensure that the vent louver is in the open position in each exhaust vent.
5. Examine the filters in the AHUs and change these filters on a regular basis. Consider increasing the dust spot efficiency of filters to increase the removal of particulate from the environment.

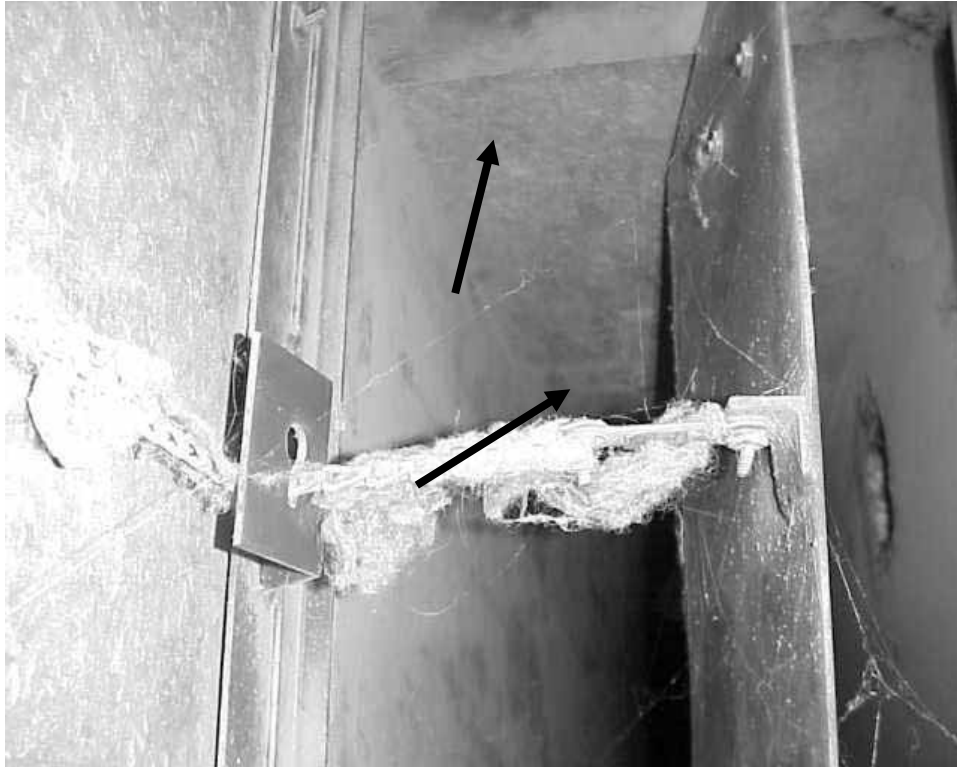
**Picture 5**

**Exhaust Vent Louver and Pulley Control System**

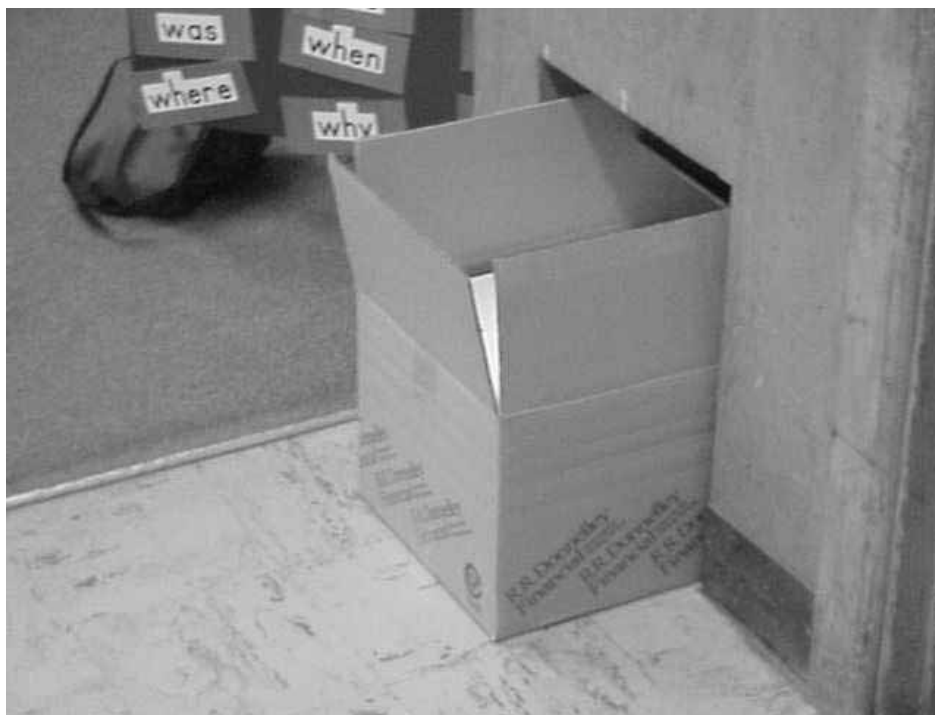
**Picture 6**

**Exhaust Vent Blocked with Box**

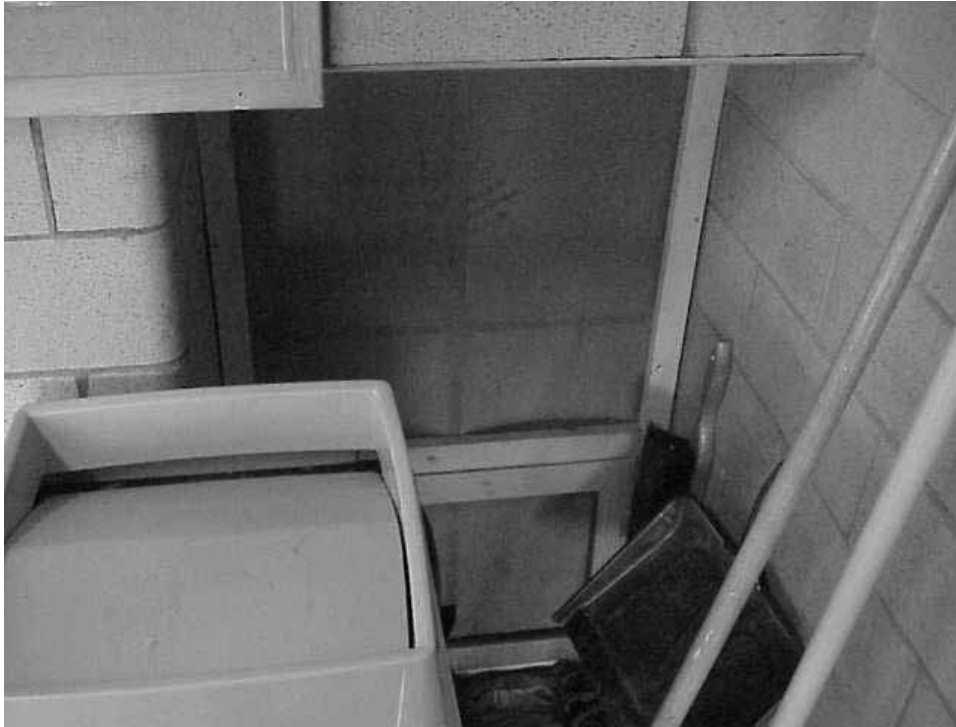
**Picture 7**

The cafeteria has an exhaust system that has a vent covered with a fine mesh screen (see Picture 7). The surface of the porous sheet metal was heavily occluded by accumulated dust, reducing the ability of this vent to draw exhaust air from the cafeteria. The small diameter of the mesh tends to clog with ordinary dust, which inhibits airflow.

**Fine Wire Mesh Covering Cafeteria Exhaust Vent**

8. Replace the wire mesh over the cafeteria exhaust vent with a louvered grille to increase draw of exhaust air.
9. Examine the feasibility of increasing drainage in areas of the roof prone to water pooling.

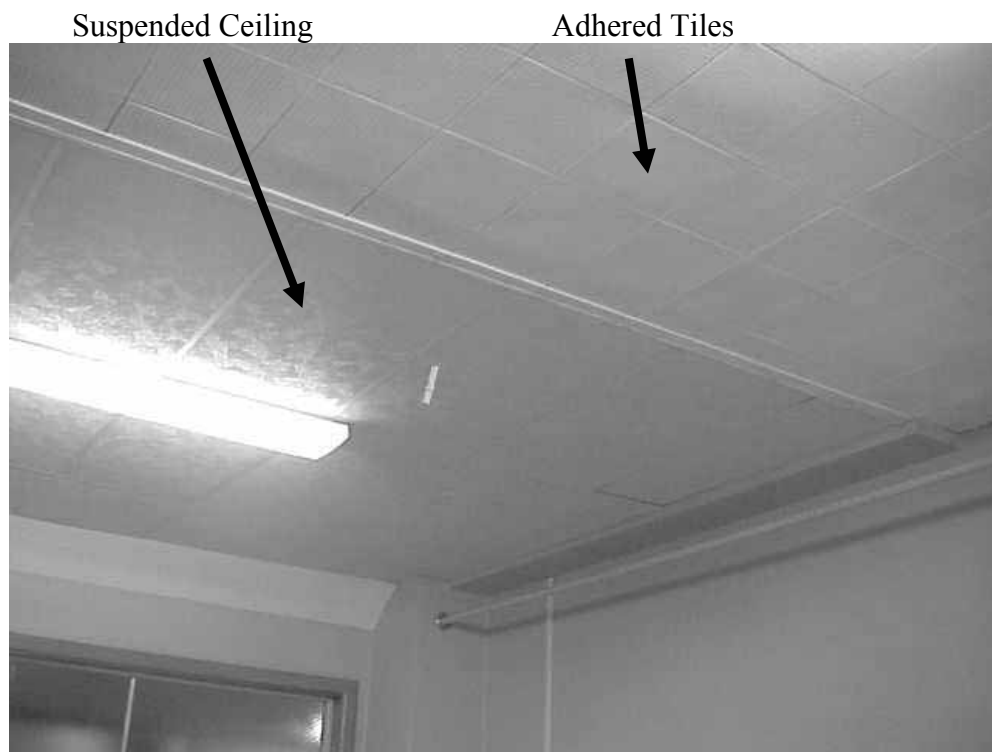
**Picture 8**

A number of rooms had water-stained ceiling tiles, which are evidence of leaks from the roof. Each classroom has two types of ceiling tiles: one that is inserted into a suspended ceiling (see Picture 8), the other directly adhered to the ceiling. Classrooms originally had skylights (see Picture 9 for an example), which were sealed behind a suspended ceiling (see Picture 10). It appears that historical water leaks wet tiles throughout the building. This water damage appears heaviest around ceiling openings for the skylights. The source of this moisture may be cracks in skylight glass (see Picture 11). The school has a ceiling tile system that is glued directly to the ceiling. A number of classrooms have ceiling tiles that appear to be water-damaged. Replacement of the adhered ceiling tiles is difficult, since their removal appears to necessitate the destruction of the tile, which can result in the aerosolization of particulates. Water-damaged ceiling tiles may provide a medium for mold and mildew growth and should be replaced after a water leak is discovered and repaired.

**Suspended Ceiling Over Skylight and Tiles Adhered to Ceilings in Classrooms**

6. Once fresh air supply and exhaust systems are functioning, the ventilation system needs to be balanced.
7. Water-damaged ceiling tiles should be replaced. These ceiling tiles can be a source of microbial growth and should be removed. The source of water leaks (e.g., broken skylight windows and roof leaks) should be identified and repaired. Examine the non-porous surface beneath the removed ceiling tiles and disinfect with an appropriate antimicrobial.

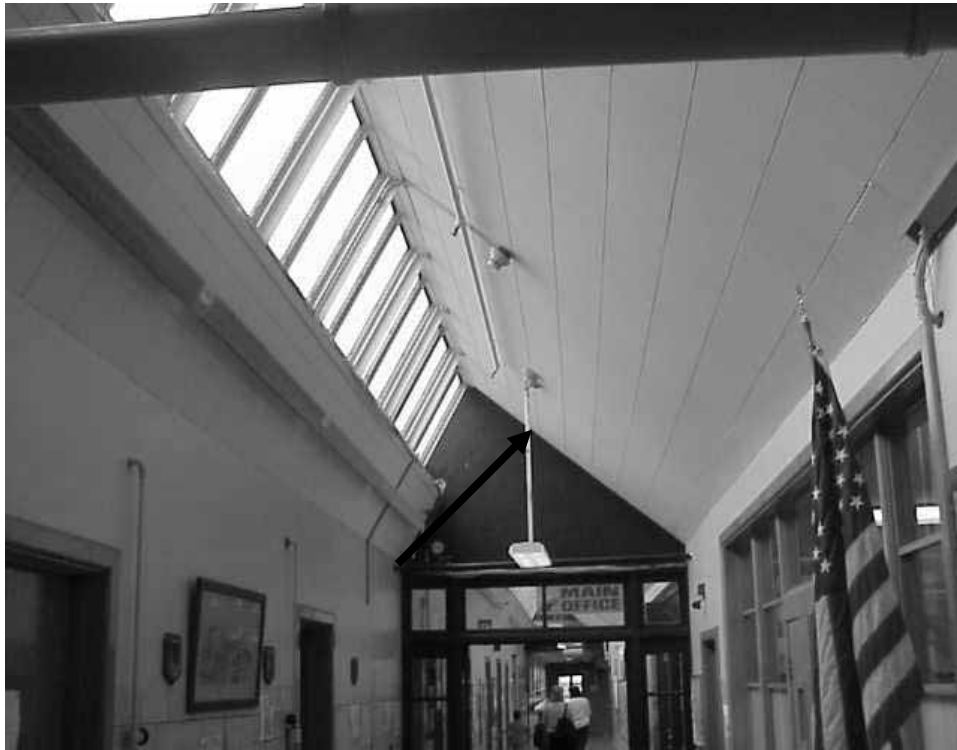
**Picture 9**

**Example of Skylight Sealed in Classrooms**

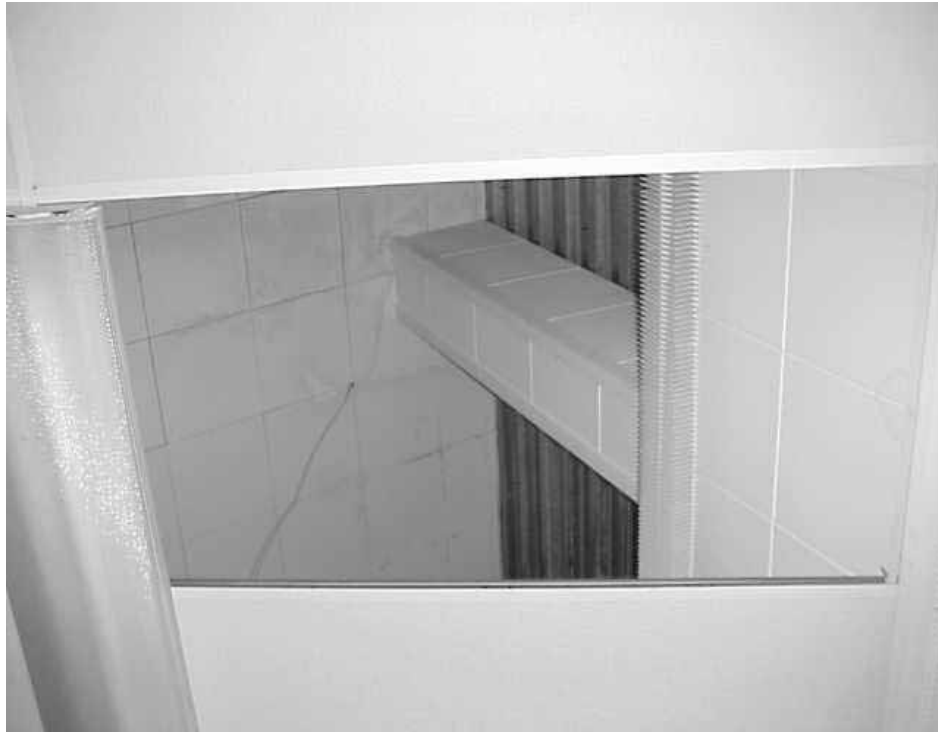
**Picture 10**

**Skylight Sealed behind Suspended Ceiling**

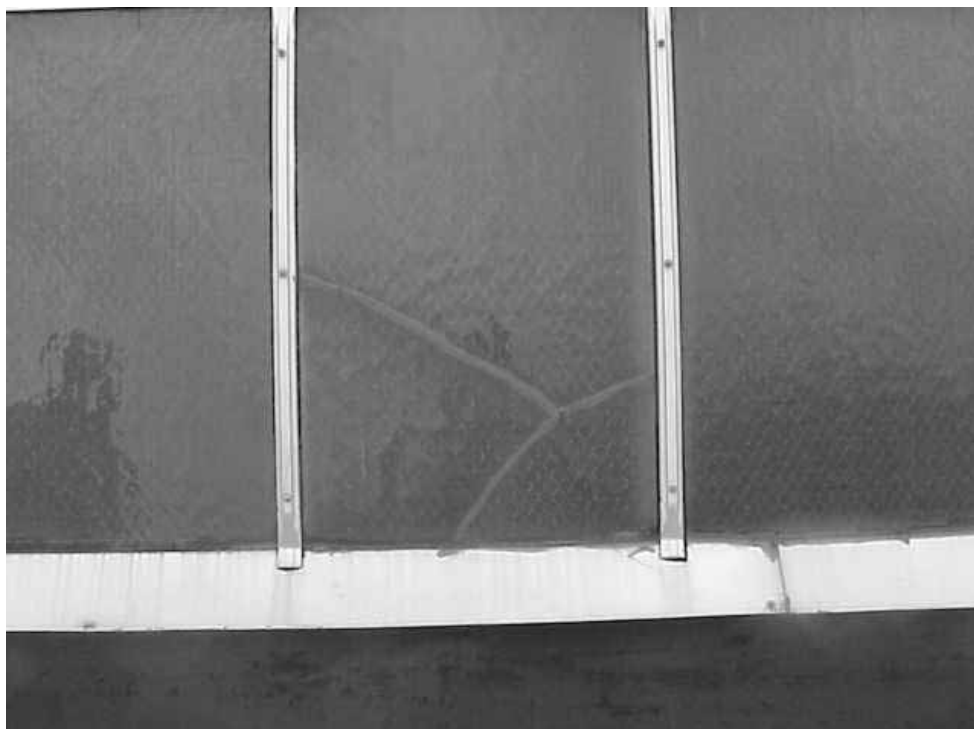
**Picture 11**

**Cracked Skylight Glass**

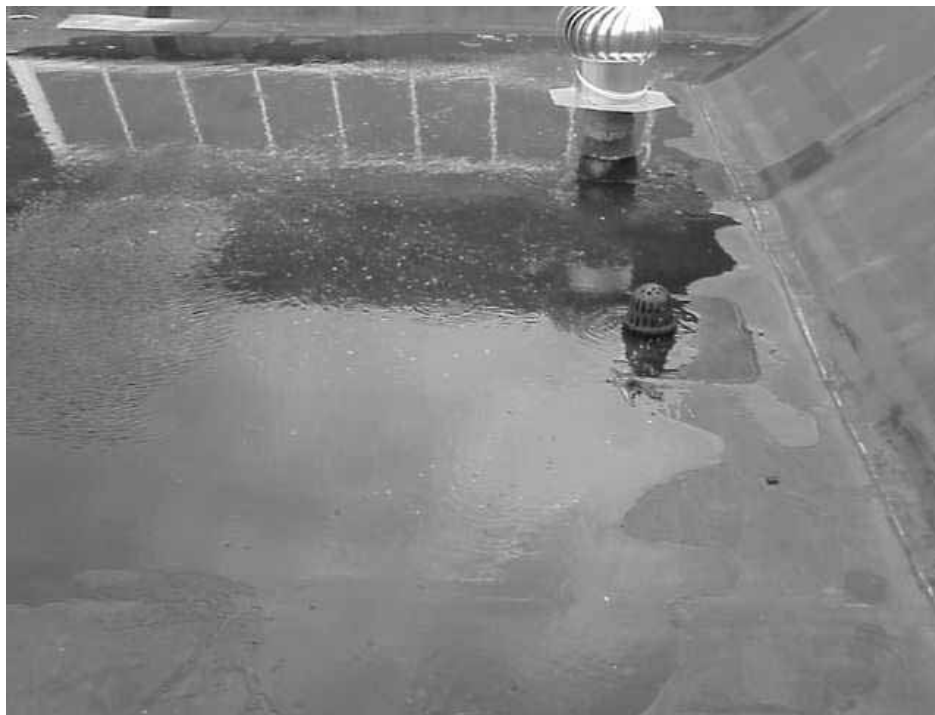
**Picture 12**

Pooling water was noted on the roof, indicating poor drainage (see Picture 12). Pooling water was also noted on the cantilever roof on the exterior wall (see Picture

**Pooling Water on Roof**

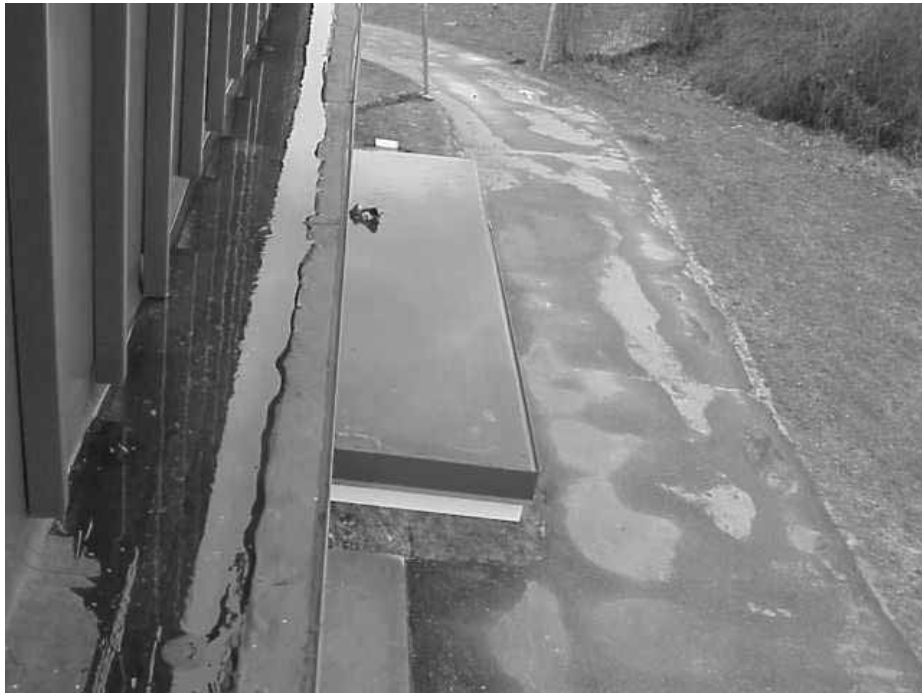
**Picture 13**

13). This roof has no support beneath it. The added weight of the water can increase tension, pulling this structure away from the building, and ultimately damaging the brickwork.

**Cantilever Roof with Pooled Water**

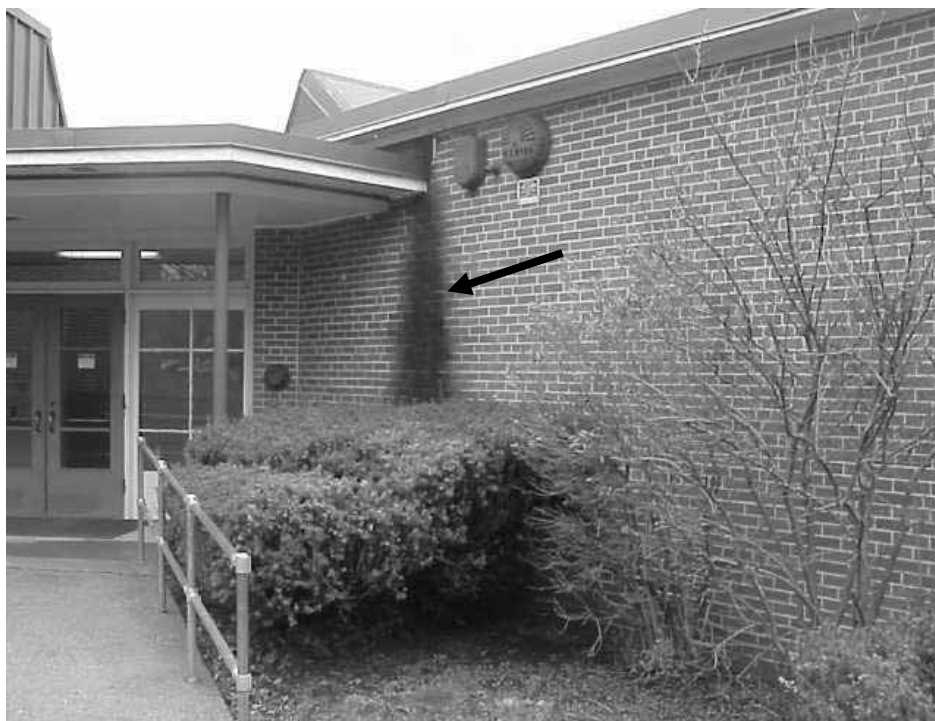
**Picture 14**

Water stained brick at the edge of the roof over the building's front door was evident (see Picture 14). The extent of this staining indicates long-term rainwater exposure of this brick. Water should be directed away from the exterior brick to prevent water penetration.

**Water Damaged Exterior Brick**

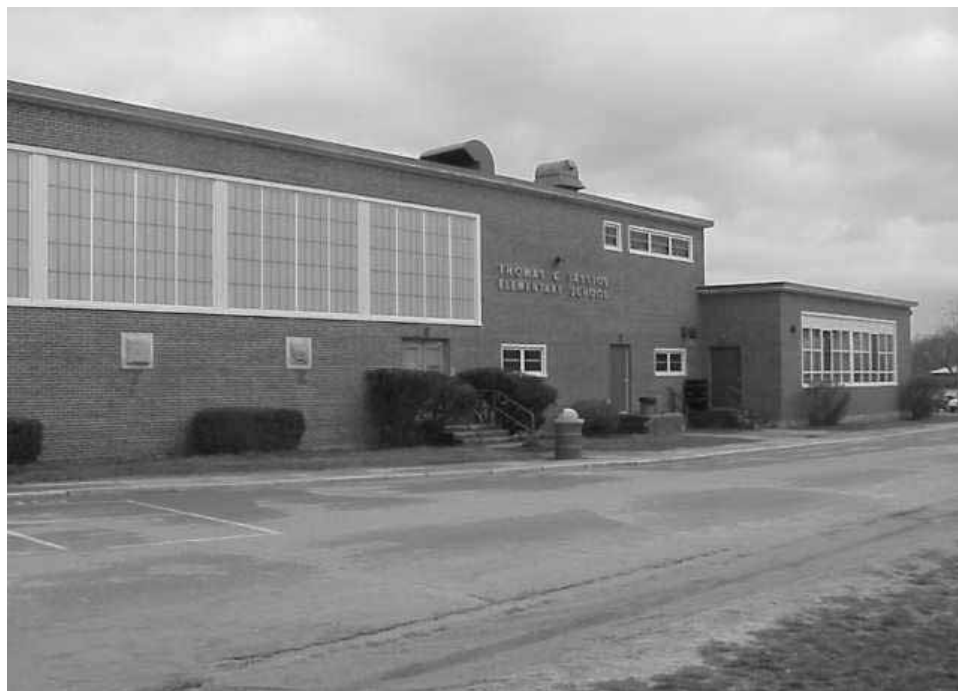
**Picture 15**

Shrubbery in direct contact with the exterior wall brick was noted in several areas around the building (see Picture 15). Shrubbery can serve as a possible source of water impingement on the exterior curtain wall due to the location of plants growing directly against the building. Plants retain water and in some cases can work its way into mortar and brickwork causing cracks and fissures, which may subsequently lead to water penetration and possible mold growth.

**Shrubbery Growing against the School Exterior Wall**

11. Reduce/trim or remove plants that are growing against the exterior brick curtain wall.
12. Seal abandoned drains or wet dry drain traps regularly to prevent odor migration into classrooms.

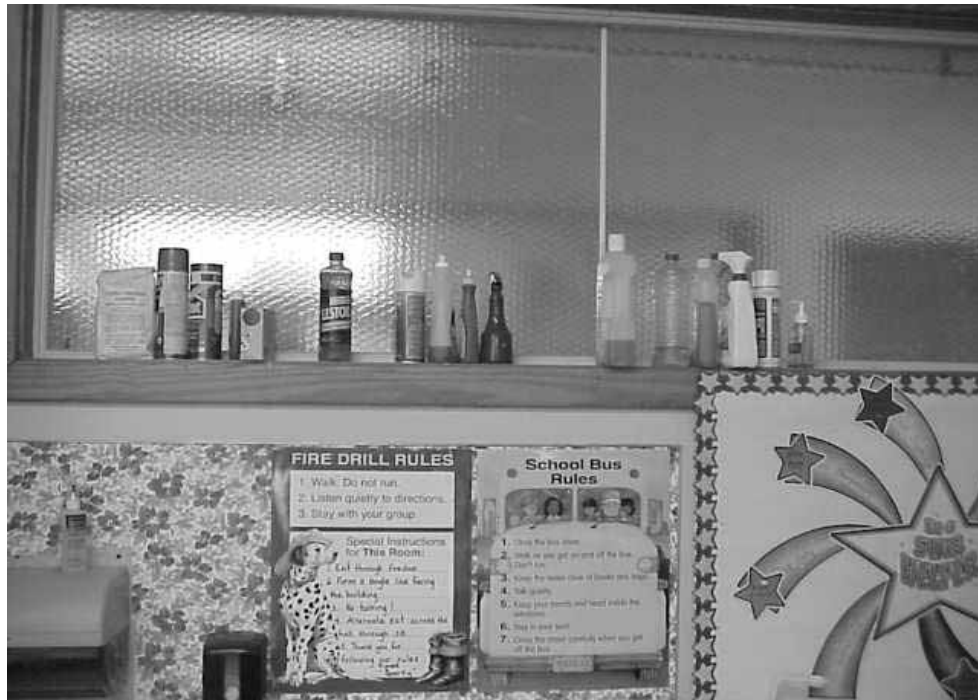
**Picture 16**

Of note is the prolific use of cleaning materials in this building (see Pictures 16). Cleaning materials frequently contain ammonium compounds or sodium hypochlorite (bleach-products), which are alkaline materials. Pesticides (see Picture 17), iodine (see Picture 18), restroom disinfectant (see Picture 19) and other materials were found in

**Cleaners Found in One Classroom**

13. Reduce the use of cleaning materials that contain respiratory irritants (ammonia related compounds) on floors and in classrooms. Do not use these materials to disinfect equipment that comes into close contact with the respiratory system (e.g., telephones). Substitute plain soap and hot water for ammonia related cleaning products. Use of ammonia related cleaning products should only be where necessary. If ammonia containing cleaning products are used, rinse the area of application with water to remove residue.

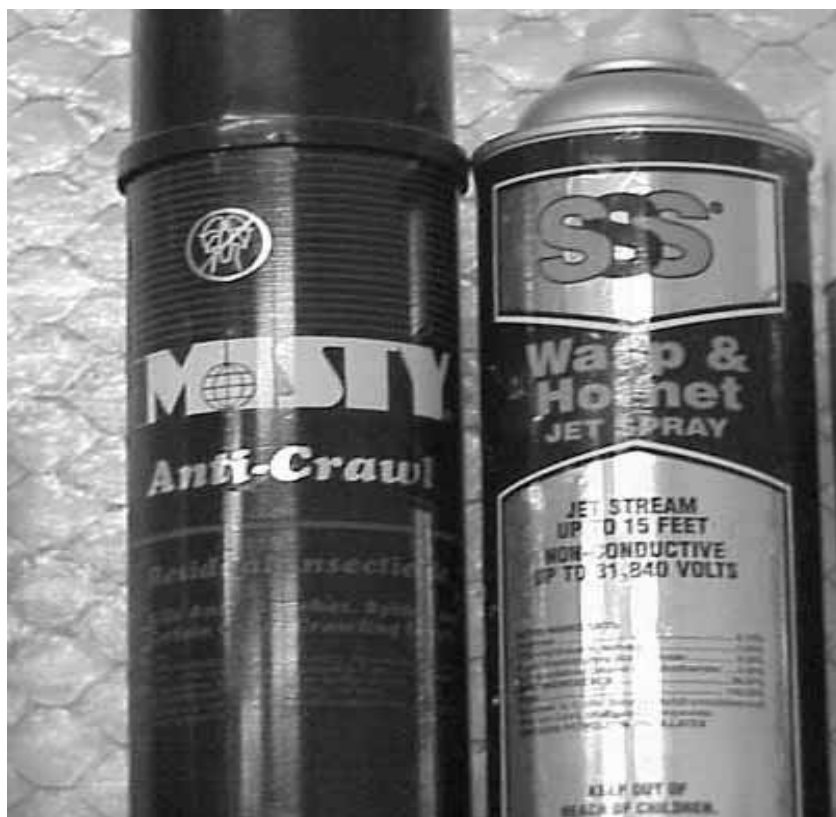
Picture 17

Pesticides Found in a Classroom

16. Have a chemical inventory done in all storage areas and classrooms. Properly store flammable materials in a manner consistent with the local fire code.  
Discard hazardous materials or empty containers of hazardous materials in a manner consistent with environmental statutes and regulations. Follow proper procedures for storing and securing hazardous materials. Obtain Material Safety Data Sheets (MSDS) for chemicals from manufacturers or suppliers. Maintain these MSDS' and train individuals in the proper use, storage and protective measures for each material in a manner consistent with the Massachusetts Right-To-Know Law, M.G.L. c. 111F. (MGL. 1983

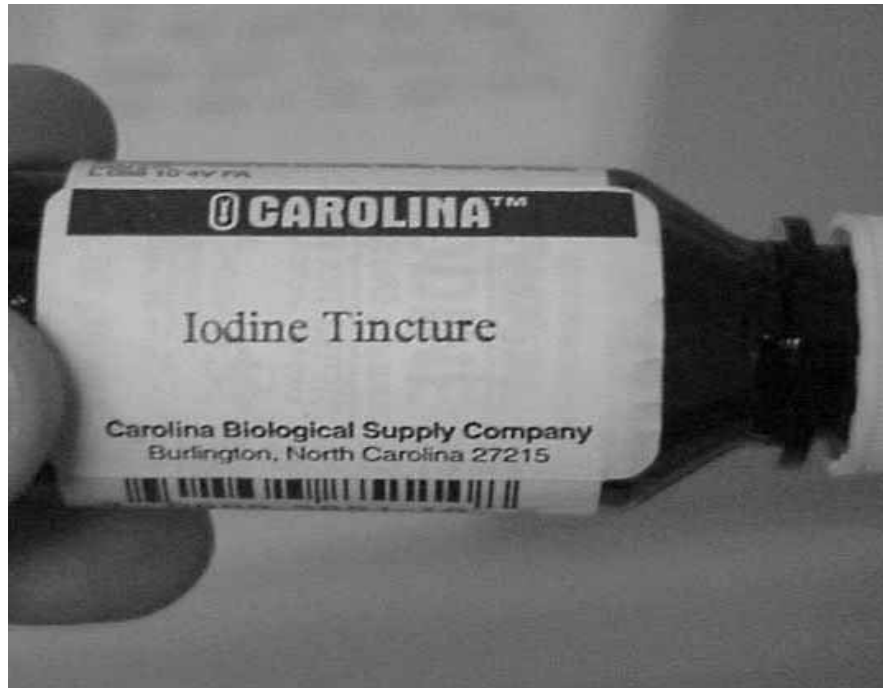
**Picture 18**

**Iodine Tincture Found in a Classroom**

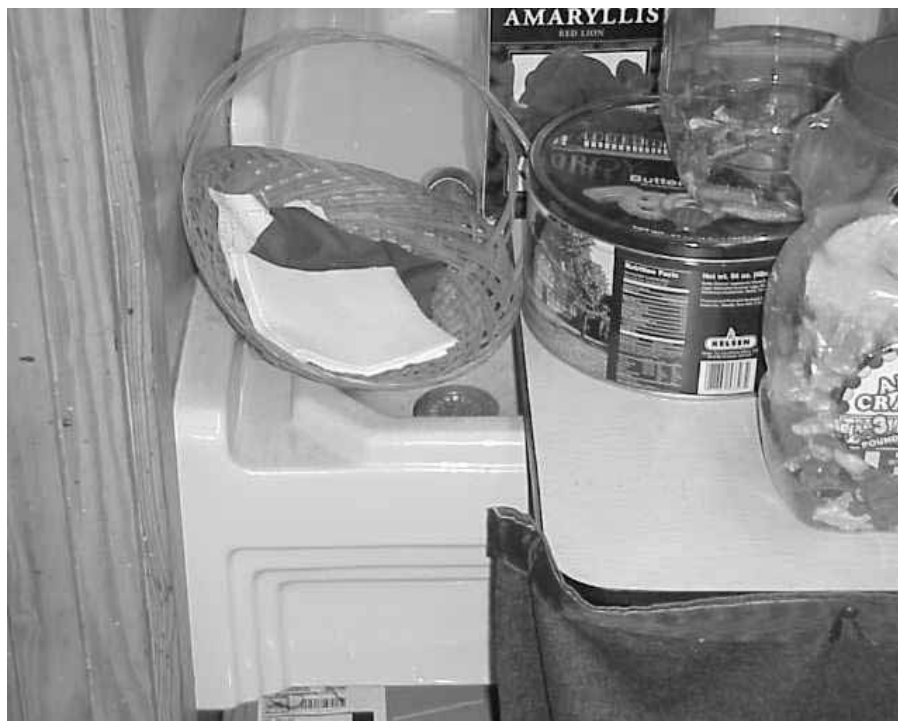
**Picture 20**

Classrooms have sinks, several of which are not in use (see Picture 20). This condition can lead to drain traps drying out, subsequently leading to sewer gas odors penetrating into the room through the unsealed trap. Sewer gas odors can be irritating to the eyes, nose and throat.

**Unused Sink in Classroom**
